# Service Bulletin

Bulletin No.: 17-NA-394

**Subject: Squeak, Clunking Type Noise Heard From Rear of Vehicle**

Brand:	Model:	Model Year:		VIN:		Engine:	Transmission:
		from	to	from	to		
Chevrolet	Colorado	2015	2022			All	All
GMC	Canyon	2015	2022

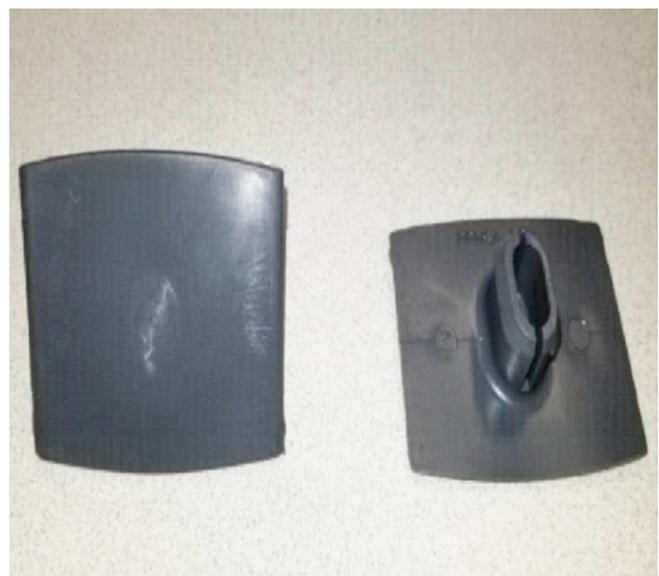
5341853

1. Raise the vehicle on a frame lift-type hoist. Refer to *Lifting and Jacking the Vehicle*, in SI.
2. Inspect the springs for damage.
  - If damage has been found, refer to *Rear Leaf Spring Replacement*, in SI.
  - If damage has NOT been found, proceed to the next step.
